**SAFETY
ALERT**

GROUND DAMAGE INCIDENTS CAUSED BY LIQUID NITROGEN OVERFLOW

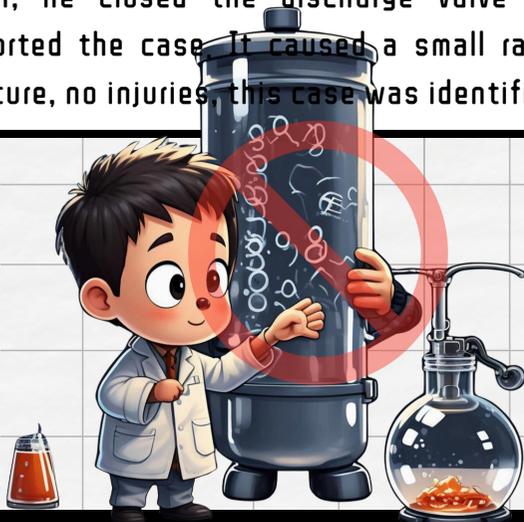
About 2 minutes later, when he returned to the lab again, he found that the liquid nitrogen had overflowed to the lab floor. He closed the discharge valve immediately and reported the case. It caused a small range of PVC floor rupture, no injuries. This case was identified as Near Miss.

No procedure indicates that the whole process of liquid nitrogen filling task should be under monitoring and the filling task should be carried out in a secondary container (leakage tray)

There is no training record for all personnel who would perform the liquid nitrogen filling task.

Lack of communication for the handover and inadequate on-site monitoring during liquid nitrogen filling.

PVC floor is not protected against liquid nitrogen leakage.

Update SOP

Organizing local training

Make Sure any handover task have a good communication and monitor the whole process of filling.

Add carpet to liquid nitrogen handling area to protect PVC floor.
