**SAFETY
ALERT**

GROUND DAMAGE INCIDENTS CAUSED BY LIQUID NITROGEN OVERFLOW

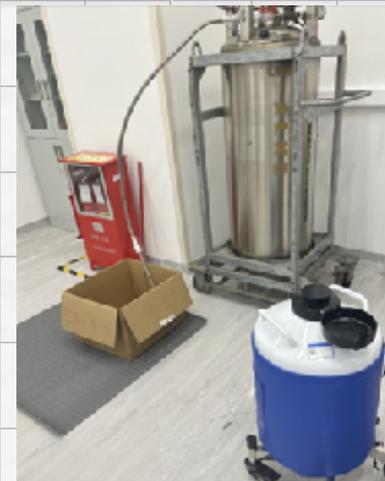
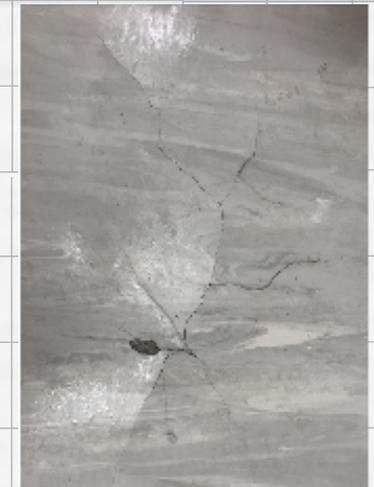
About 2 minutes later, when he returned to the lab again, he found that the liquid nitrogen had overflowed to the lab floor. He closed the discharge valve immediately and reported the case. It caused a small range of PVC floor rupture, no injuries. This case was identified as Near Miss.

PVC floor is not protected against liquid nitrogen leakage.

Make Sure any handover task have a good communication and monitor the whole process of filling.

Add carpet to liquid nitrogen handling area to protect PVC floor.
